Belgium for  
Biodiversity

remote sensing technology to monitor ecosystem restoration

**Case study Zwarte Beek**

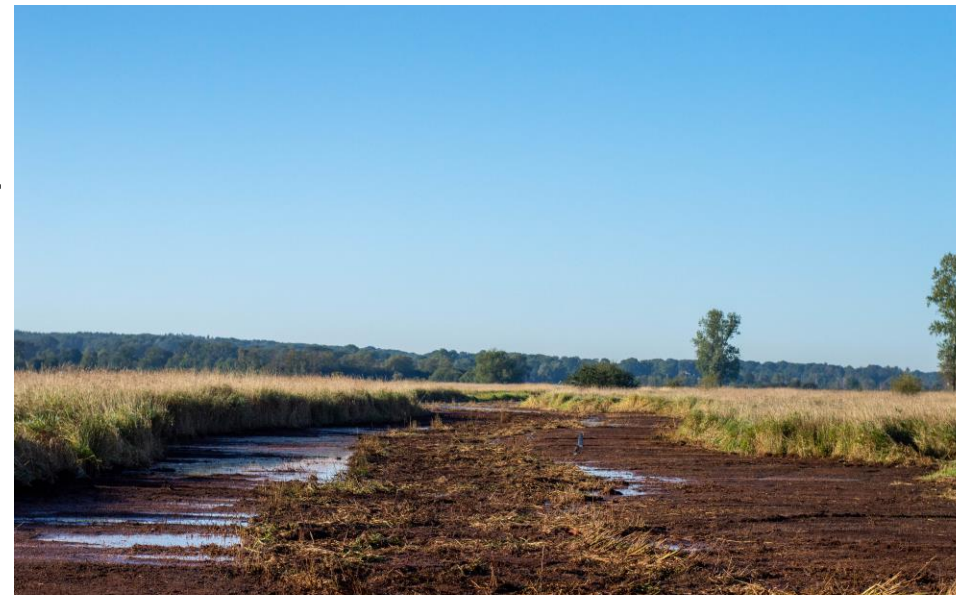
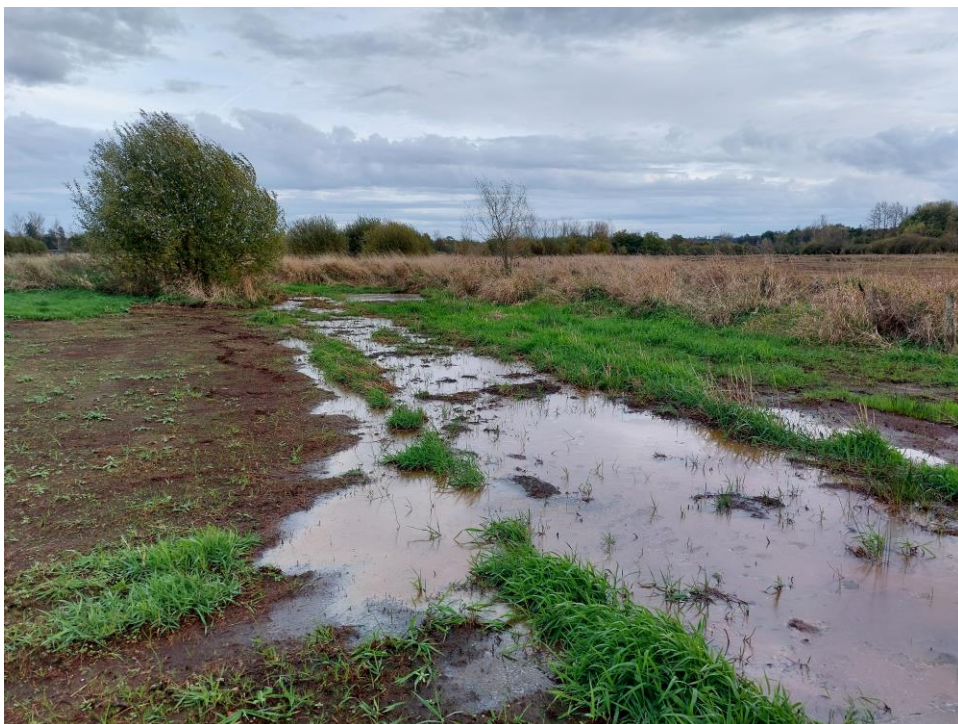
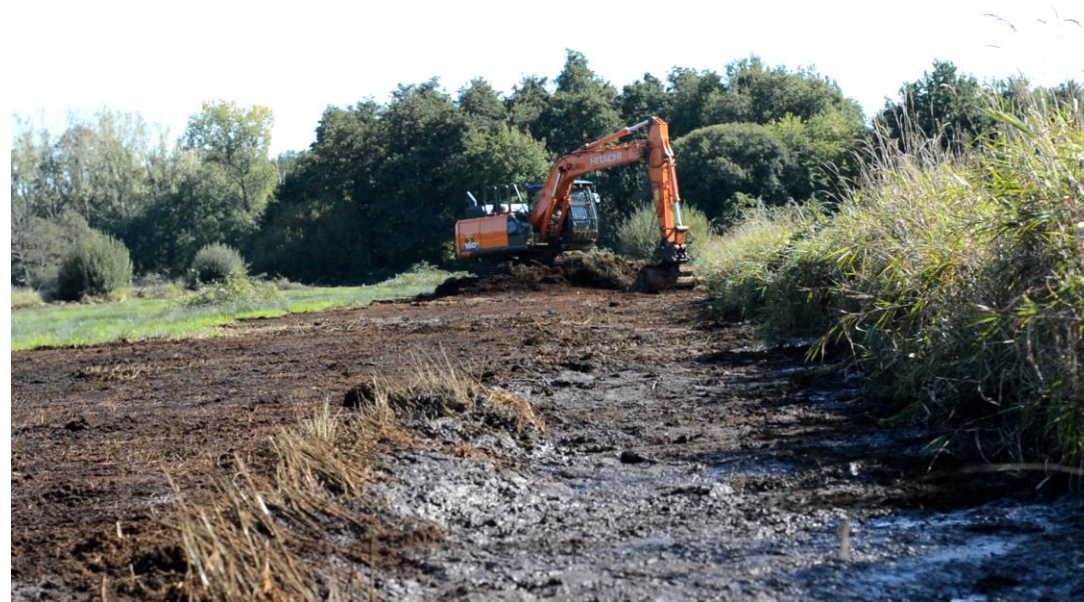
- Interreg Care-Peat and Natuurpunt Beheer
  - 3.7km of waterways relevelled

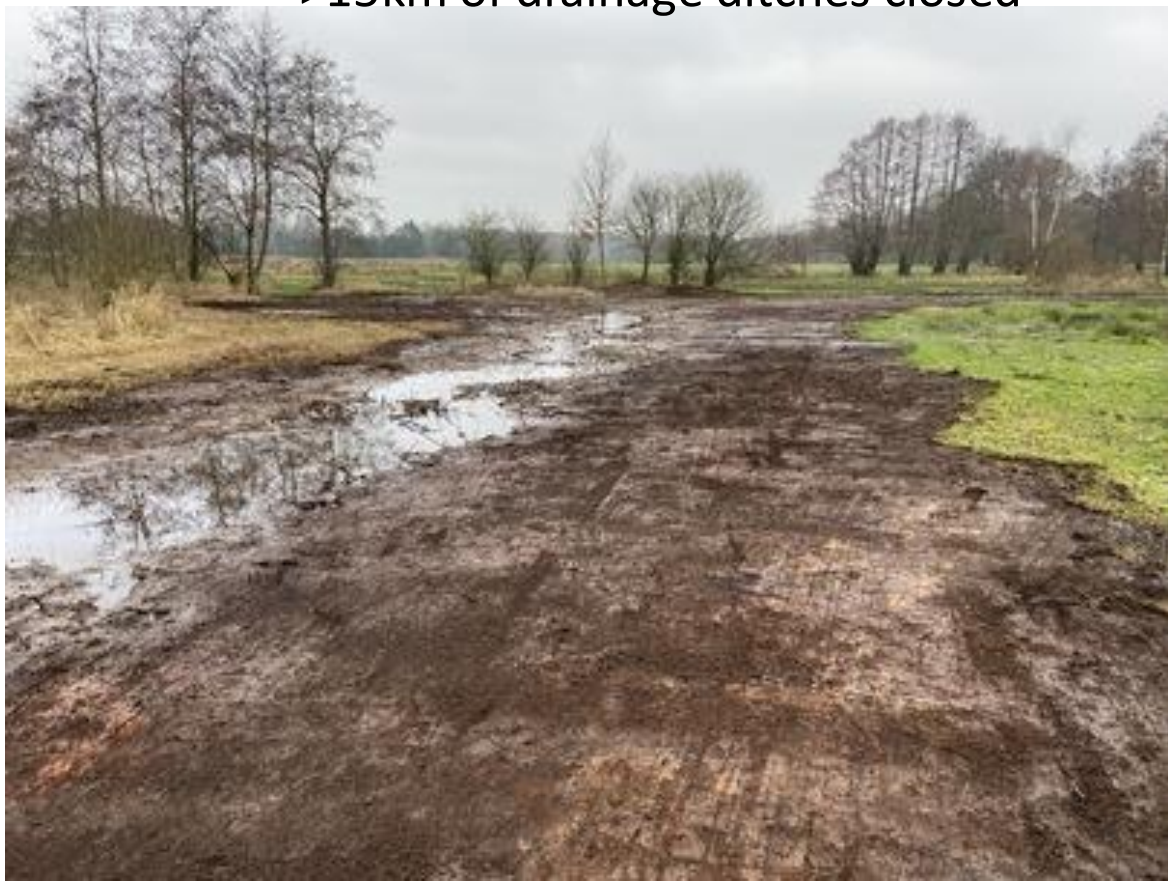
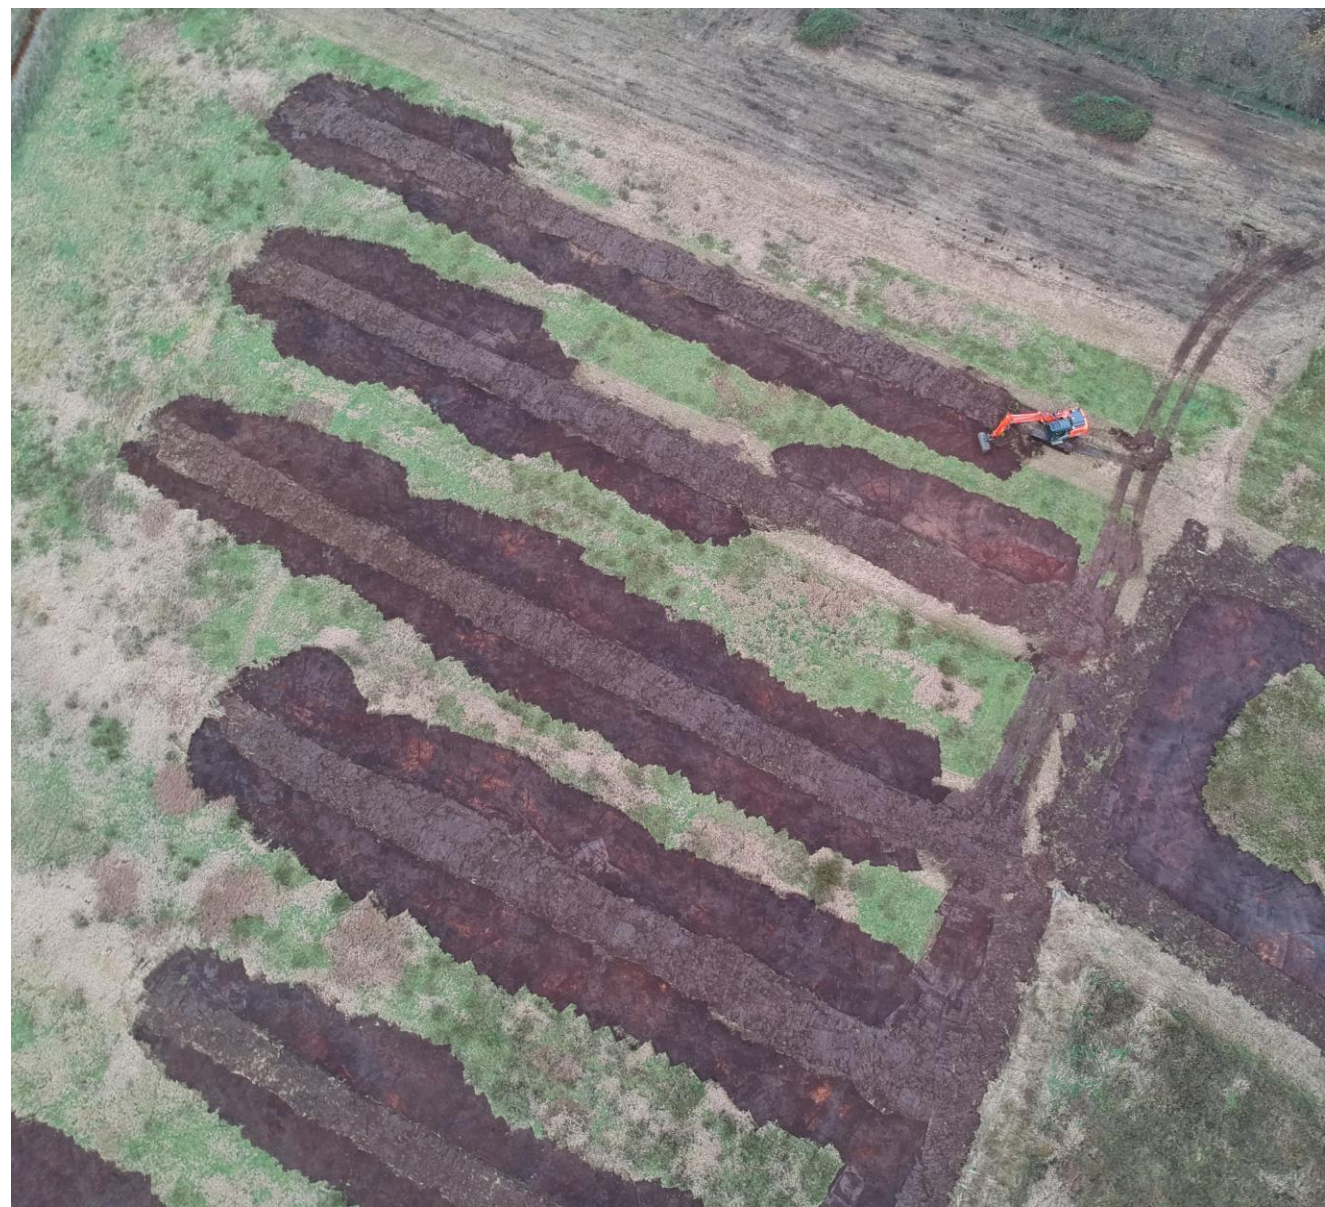
- Interreg Care-Peat and Natuurpunt
  - 3.7km of waterways relevelled
  - >15km of drainage ditches closed

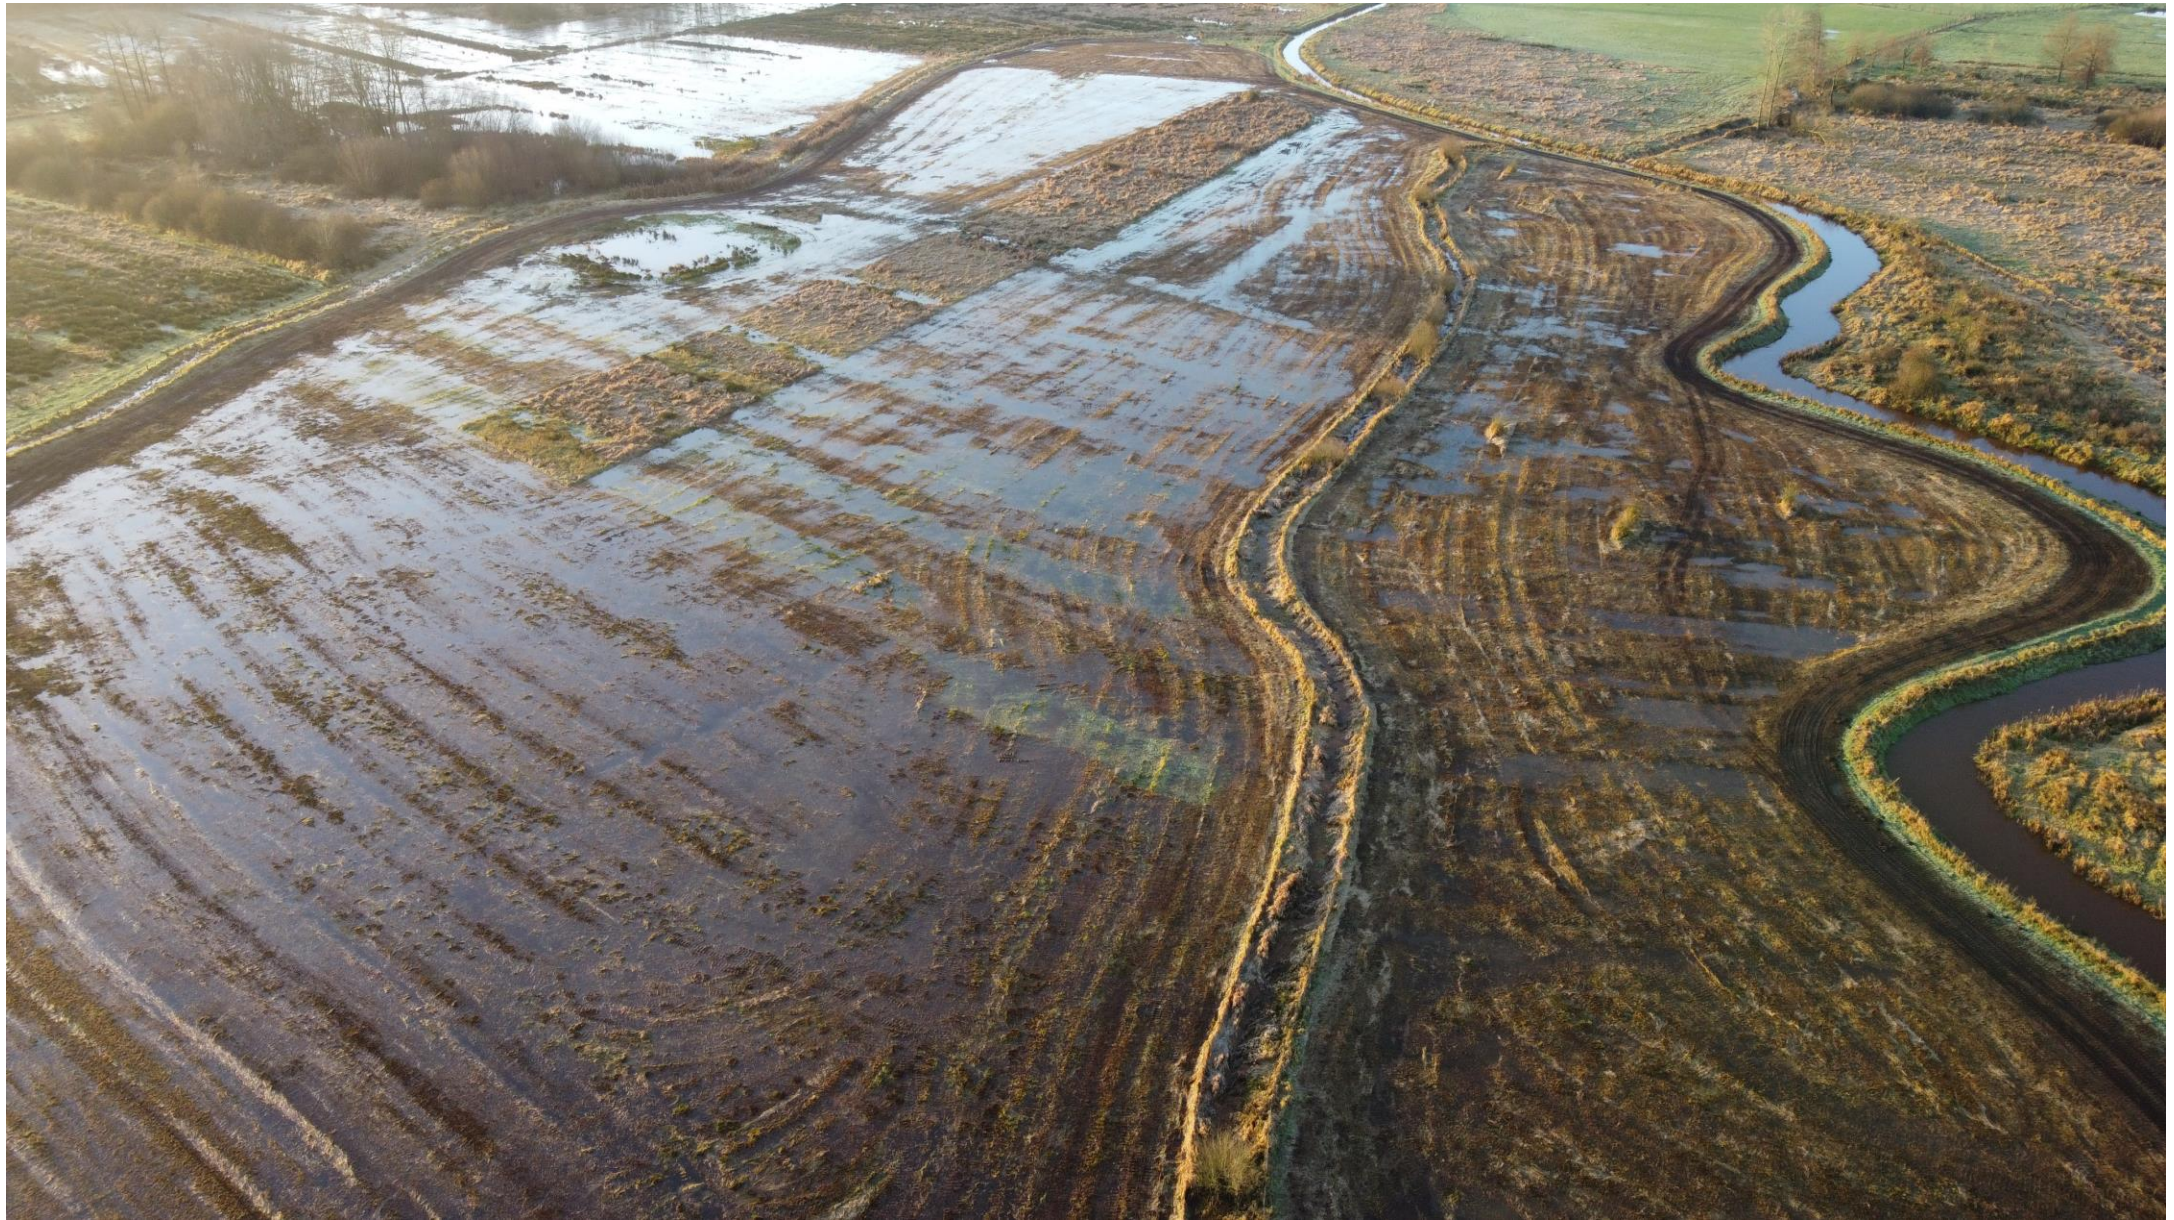
450ha mown machinally (2022)

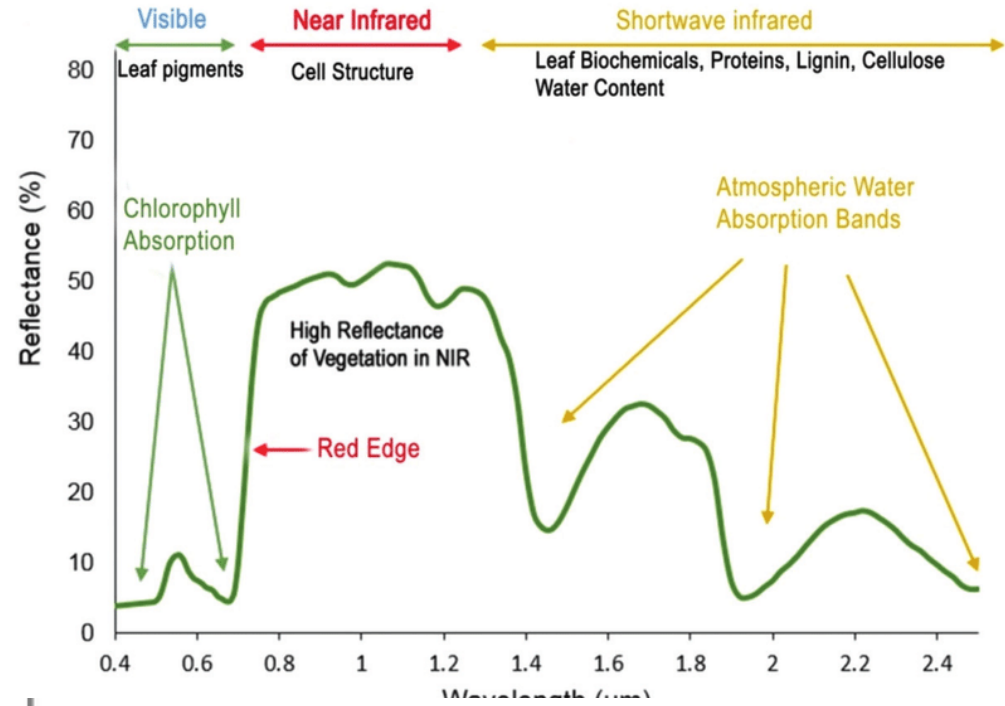
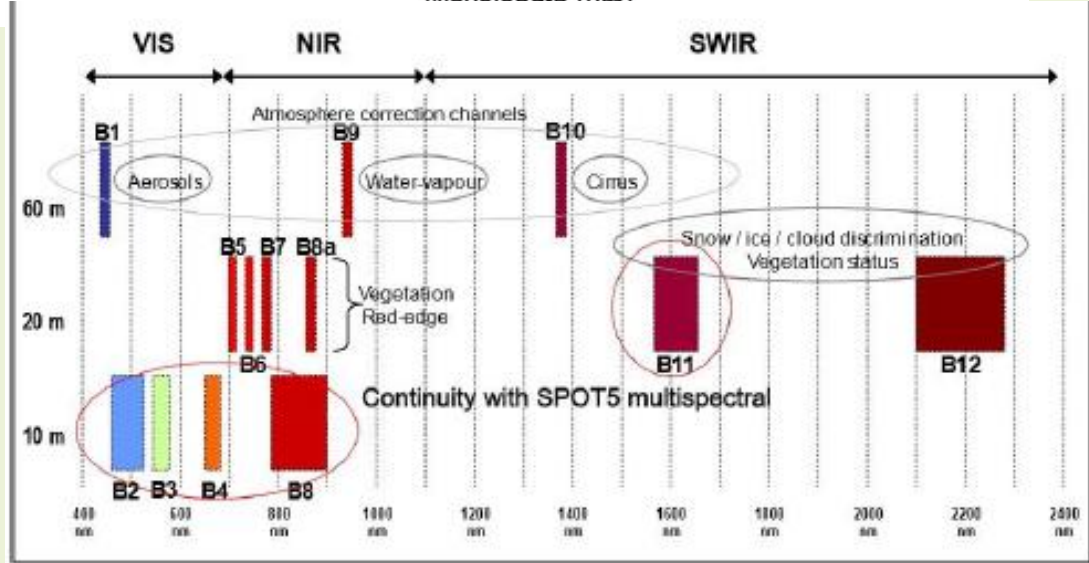
sensors benchmark report on sentinel 2A (EU)

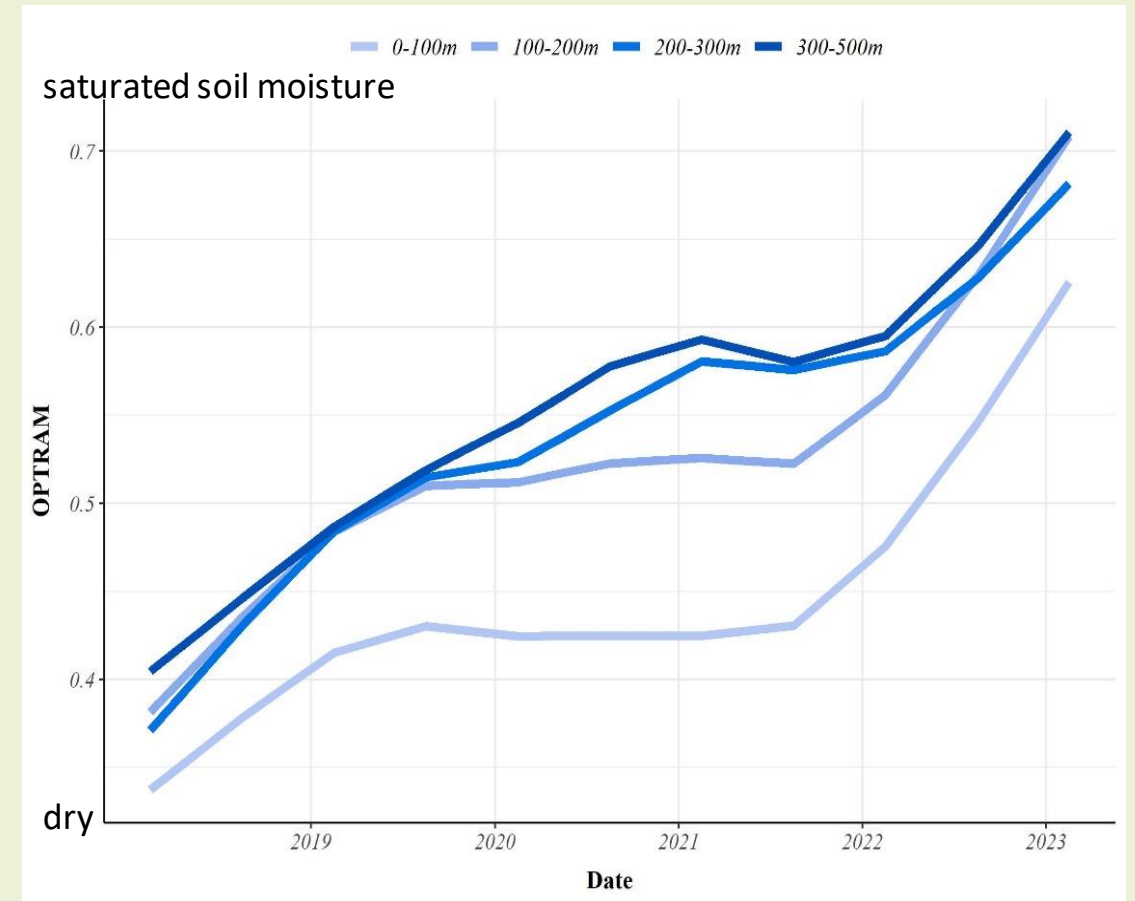
- within the Interreg Care-Peat project (by the Manchester Metropolitan University)
- To investigate the benefits of remotely sensed optical satellite imagery to monitor environmental change from peatland restoration
- Positive correspondence between site and remotely sensed measurements (such as soil moisture <> shortwave IR transformed reflectance (STR))

Conclusion: The 'rewetting' measures work, but the main creek is still a factor of drainage
